INDOOR AIR QUALITY ASSESSMENT

**Norton Middle School
215 West Main Street
Norton, MA 02766**

Prepared by:
Massachusetts Department of Public Health
Center for Environmental Health
Emergency Response/Indoor Air Quality Program
February 2006

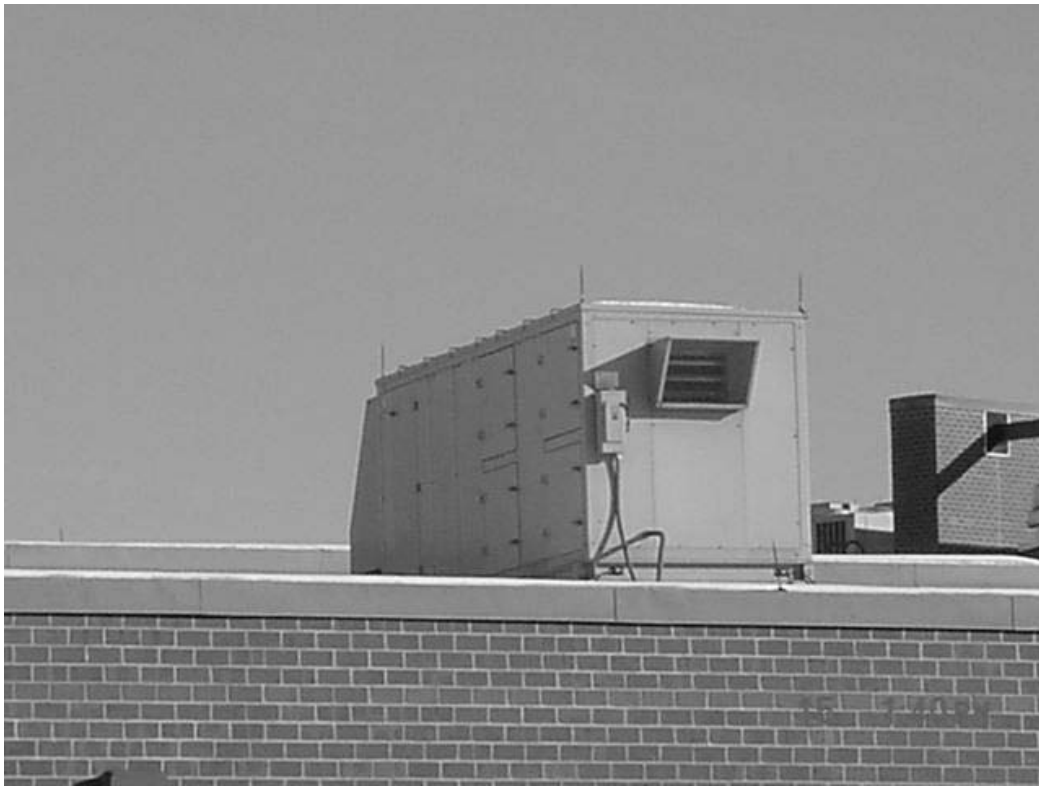
Picture 1

It can be seen from Table 1 that carbon dioxide levels were above 800 parts per million (ppm) parts of air in 27 of 53 areas surveyed, indicating poor air exchange in about half of the areas surveyed (mainly in the classroom wing) during the assessment. A heating, ventilation and air conditioning (HVAC) system controlled by a computer system provides ventilation. Fresh air is provided by rooftop-mounted air handling units (AHUs) (Picture 1). These AHUs are connected to ducts that supply fresh air to rooms through ceiling mounted air diffusers (Picture 2 and 3). By design, air diffusers are equipped with fixed louvers, which create airflow by directing the air supply along the ceiling to flow down the walls.

Rooftop Air Handling Unit

1. Continue to operate both supply and exhaust ventilation continuously during periods of school occupancy to maximize air exchange. Consult the school's heating, ventilation and air conditioning (HVAC) engineer concerning an increase in the introduction of outside air in areas indicated in Table 1.
2. Consider having the ventilation system balanced by an HVAC engineer every five years (SMACNA, 1994).
3. Close classroom doors to maximize air exchange.

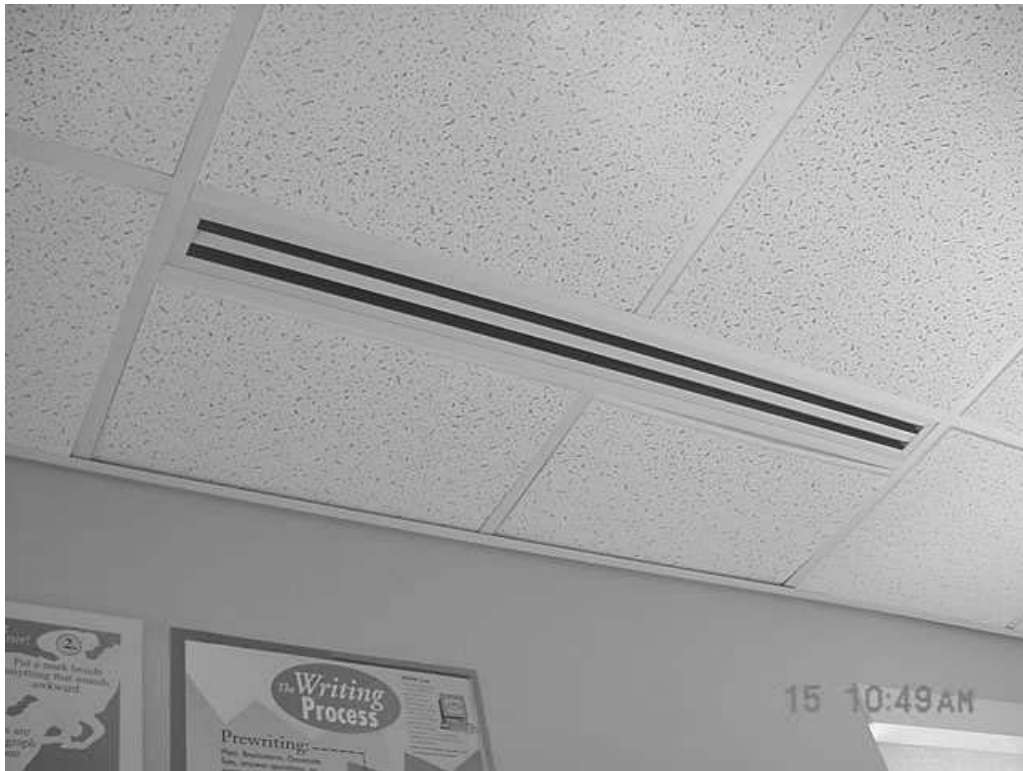
Picture 3

Slotted Air Diffuser

10. Clean personal fans, air diffusers and exhaust/return vents periodically of accumulated dust.

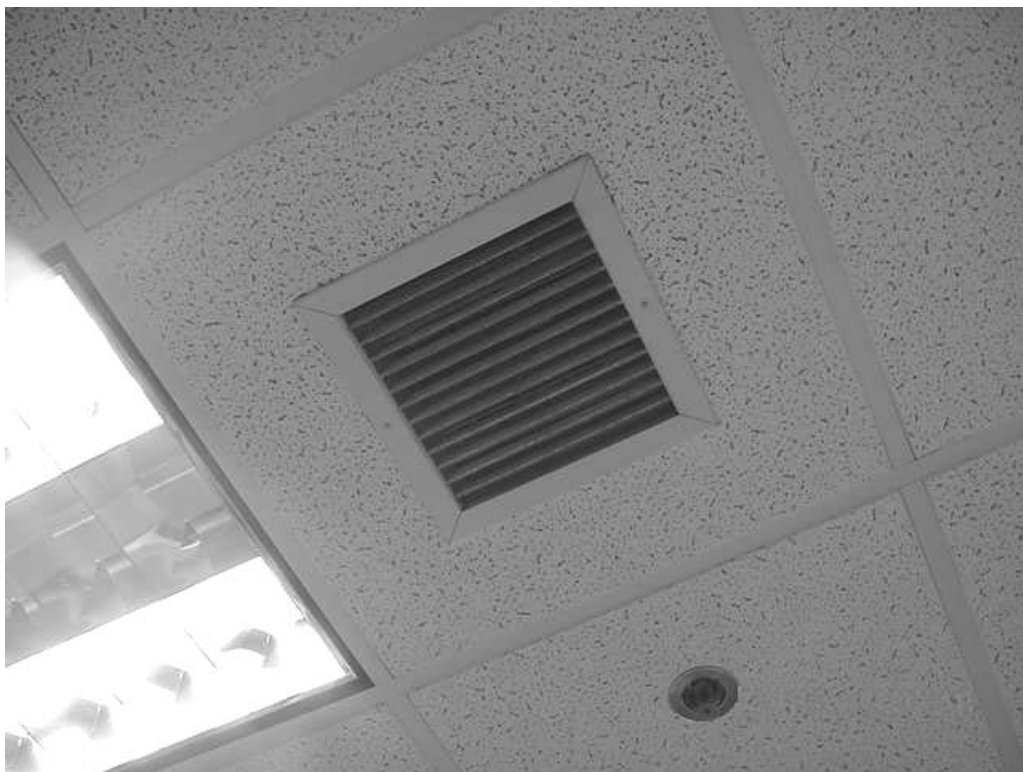
Picture 4

While it has the advantage of energy conservation and lower operating costs, VAV box systems may cause problems of insufficient outside air supply. For example, once the temperature requirement is met, airflow drops. Airflow can drop to zero in poorly performing HVAC systems (Plog, Niland and Quinlan, 1996). Please note that this condition may occur during times of outdoor temperature extremes ($< 32^{\circ}\text{F}$ or $>90^{\circ}\text{F}$). Air monitoring was conducted on a day with comfortable outdoor conditions (72°F). To ascertain whether minimal airflow conditions exist, air monitoring during temperature extremes should be considered. Air is returned back to rooftop AHUs via ceiling or wall-mounted return vents (Picture 4).

Ceiling-Mounted Return Vent

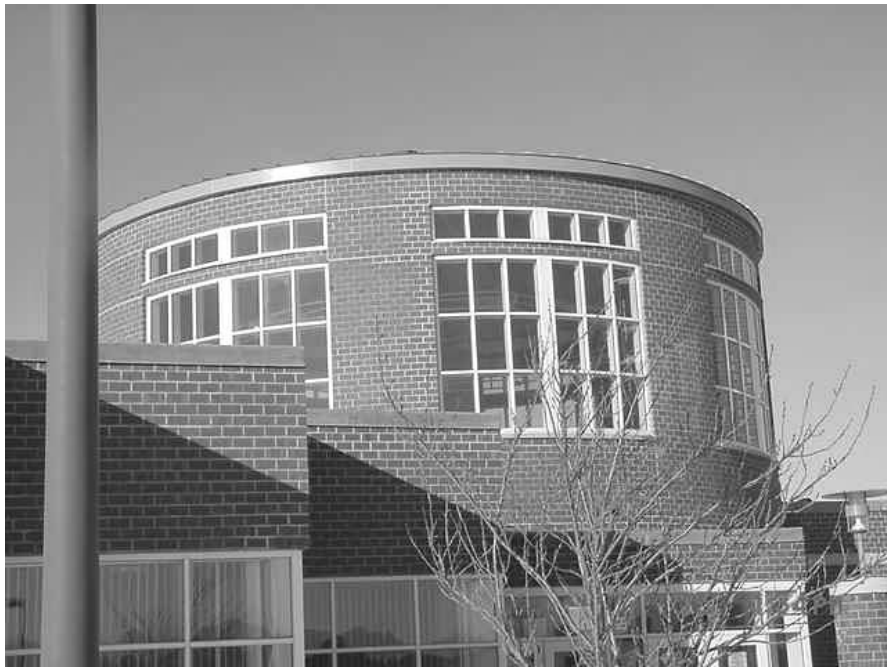
Picture 5

Mr. Texieria reported that the rotunda has experienced chronic leaks over the years resulting in peeling paint and water damage to interior walls (Pictures 5 and 6). Water penetration through the building envelope can lead to mold growth in porous building materials. In addition, a few areas had water-damaged ceiling tiles (Picture 7/Table 1), which can indicate leaks from either the roof or plumbing system. Water-damaged ceiling tiles can provide a source of mold and should be replaced after a water leak is discovered and repaired.

Exterior View of Rotunda

6. Contact a building envelope specialist and/or architectural firm to examine methods to prevent water infiltration through the rotunda. Once repaired replace water damaged building materials.

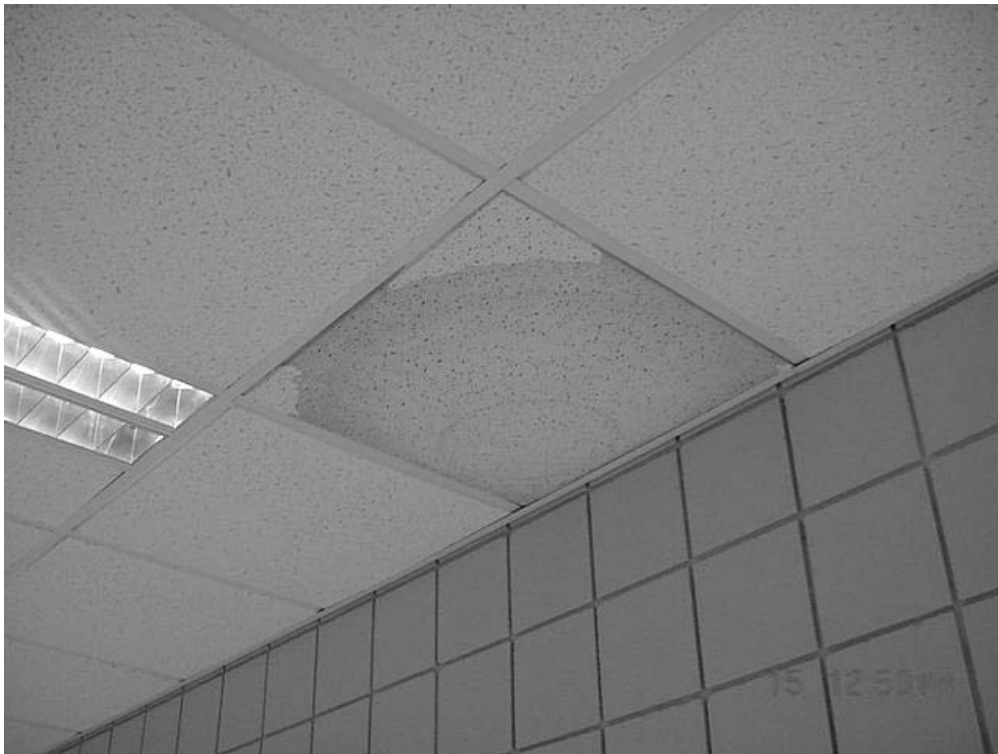
Picture 7

Water Damaged Ceiling Tile

5. Ensure roof/plumbing leaks are repaired and replace water damaged ceiling tiles. Examine the area above and around these areas for mold growth. Disinfect areas of water leaks with an appropriate antimicrobial.

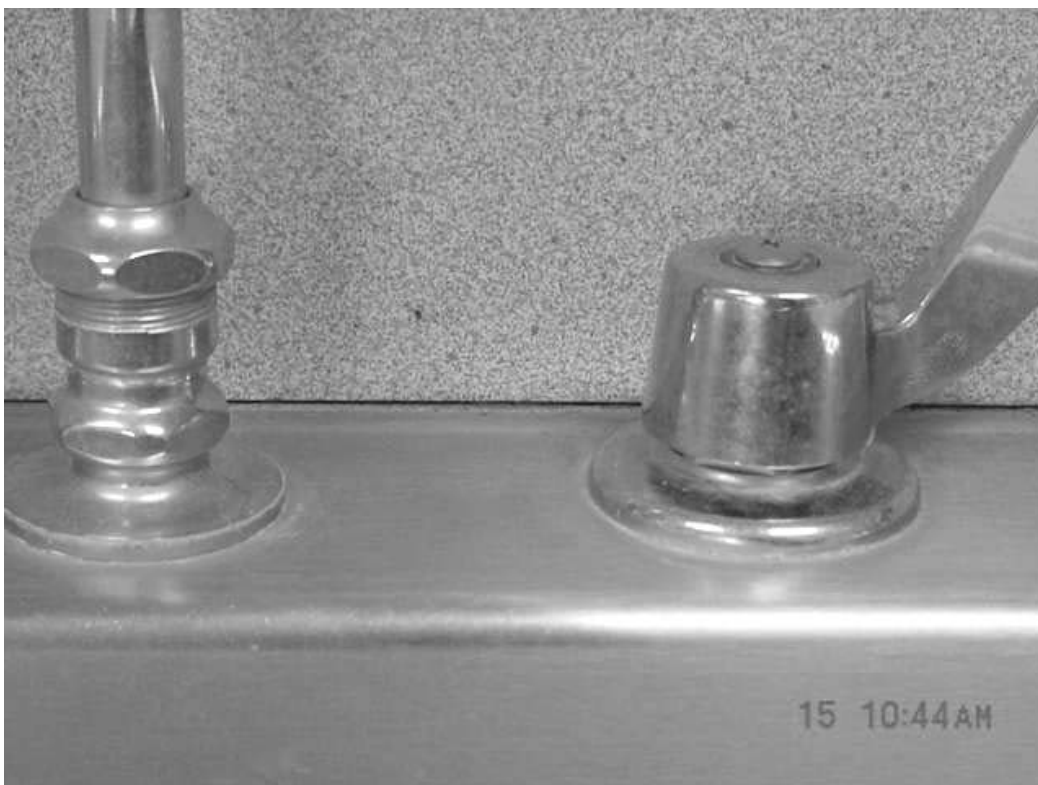
Picture 8

Spaces between the sink countertop and backsplash were noted in several classrooms (Picture 8/Table 1). Improper drainage or sink overflow can lead to water penetration to countertop wood, the cabinet interior and areas behind cabinets. Like other porous materials, if these materials become wet repeatedly they can provide a medium for mold growth.

Space between Sink Countertop and Backsplash

7. Seal areas around sinks to prevent water-damage to the interior of cabinets and adjacent wallboard.
8. Clean/maintain aquariums/terrariums to prevent mold/bacterial growth and associated odors.
